LINCOLN ARCHAEOLOGICAL STUDIES No. 4

The Archaeology of the Lower City and Adjacent Suburbs

Kate Steane

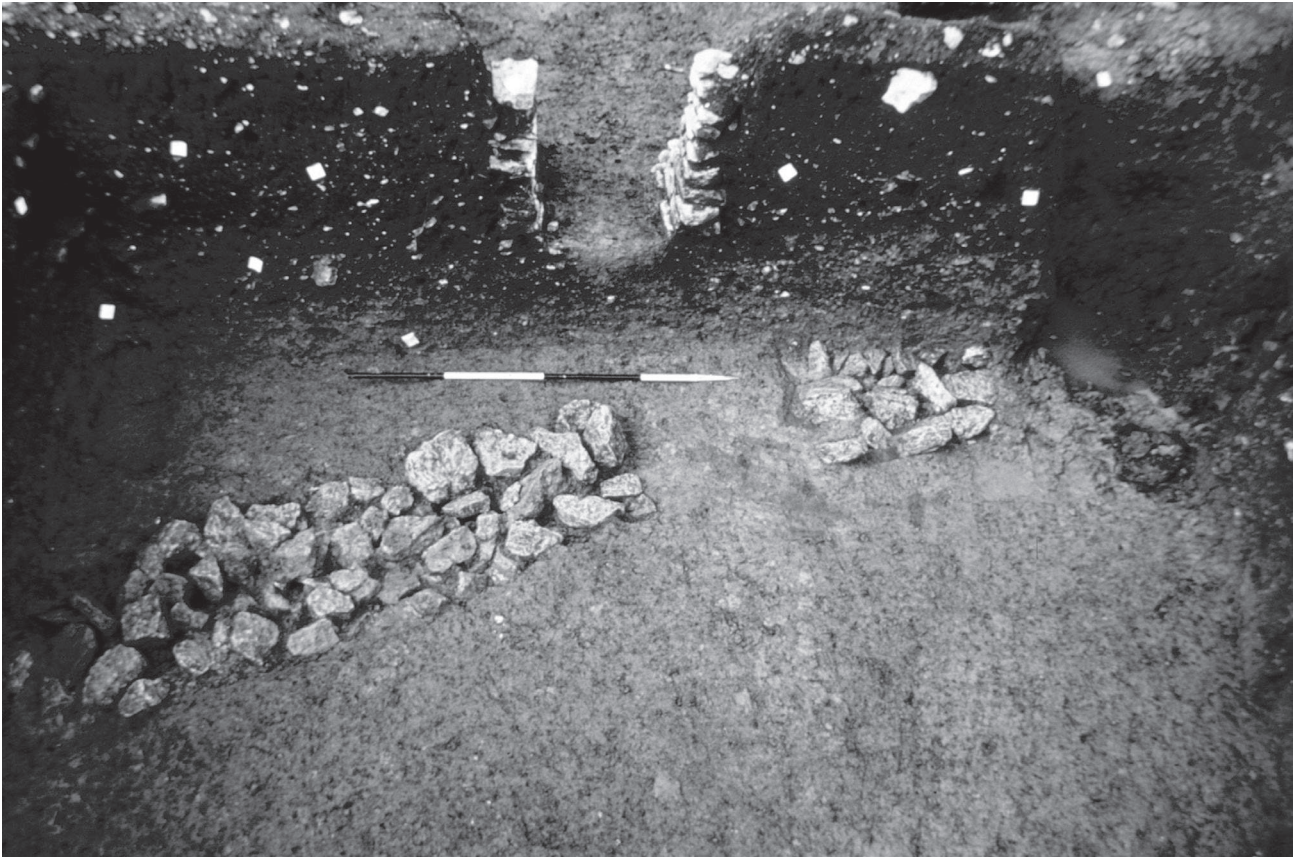
Fig. 2.36. Wall foundations *cgr11* and *cgr12* of Structure R2: LUB 5. Looking west.

In the mid to late 3rd century the area over **LUBs 3** and **4** was levelled **LUB 4**. Further east, the earliest feature uncovered was a stone-founded structure (Structure R2) **LUB 5**. It was on a different alignment from both earlier Structure R1 and later Structure R3. It produced only residual pottery.

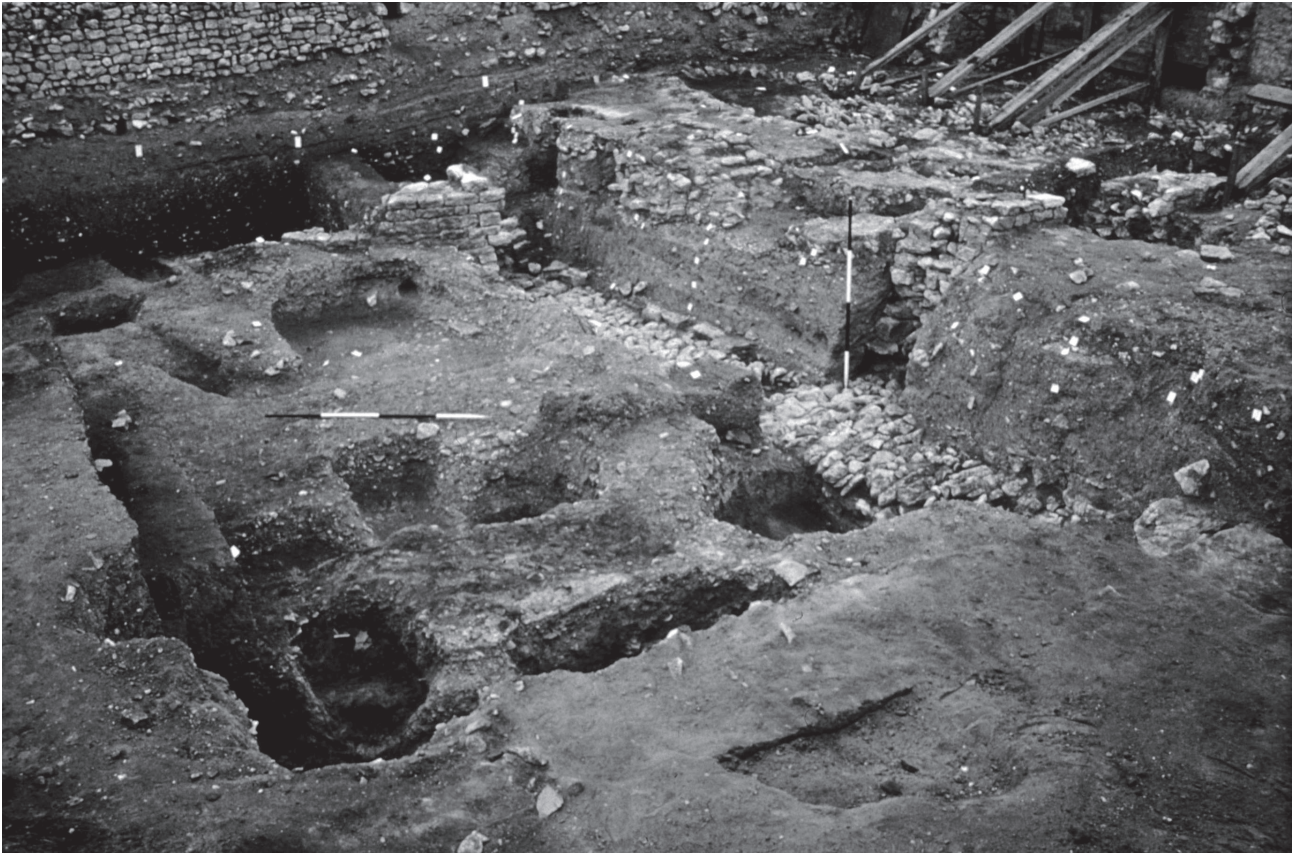
Fig. 2.38. A similar view to Fig. 2.37, but looking south-west and showing levelling deposits beneath floor in section; north wall of apse towards south section: LUB 8.

The apse wall was of one build with the east wall. It had stepped foundations with a total width of 0.8m and the wall itself was 0.7m wide. Above the foundations the wall survived to a height of *c.* 1.35m. The apse (room C) was semicircular in shape with an external radius of *c.* 3.3m, but only the northern half lay within the area of excavation (Figs 2.37–8).

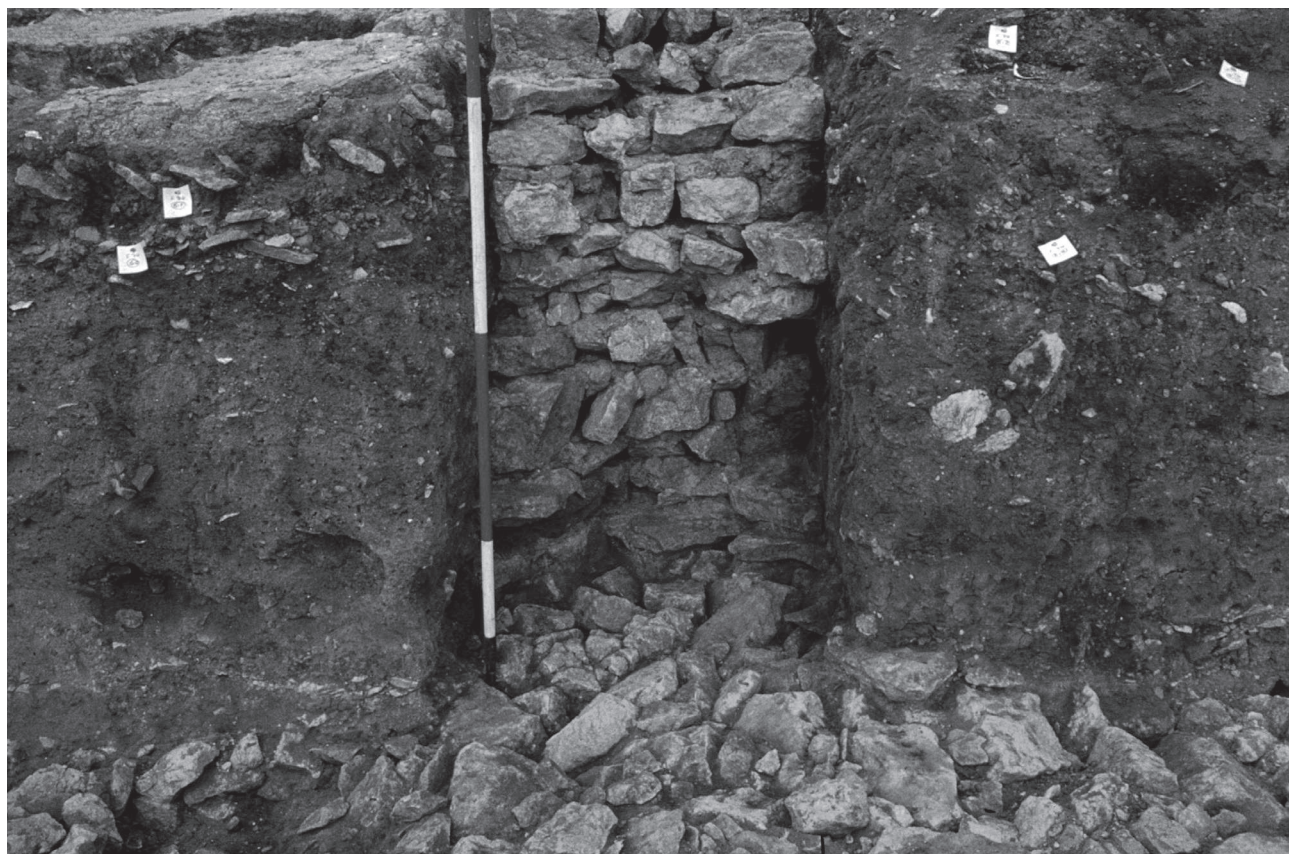
Fig. 2.39. Internal aisle? wall of Structure R3 at its junction with the main east wall cgr29; levelling dump cgr42 sealed by opus signinum floor cgr64 in room B to left of wall: LUB 10. Looking west.

Within room 3B the dumps cg42 (LUB 8) were sealed by a floor which consisted of a layer of light red *opus signinum*, cgr64, measuring 7.5m by 4m and 0.08m thick (Fig. 2.39). There were slight remains of a plain tessellated pavement above it, cgr65. (The pavement seems to have been plain but so little remained that this is uncertain.) The context record notes that the floor comprised 'pink or yellow mortar containing large numbers of tesserae, loose patches of this overlying(?) a more definite surface of tesserae, pebbles and chips of tile and stone set in yellowish brown clay or mortar... probably [the] remains of a tessellated floor which has been destroyed.'

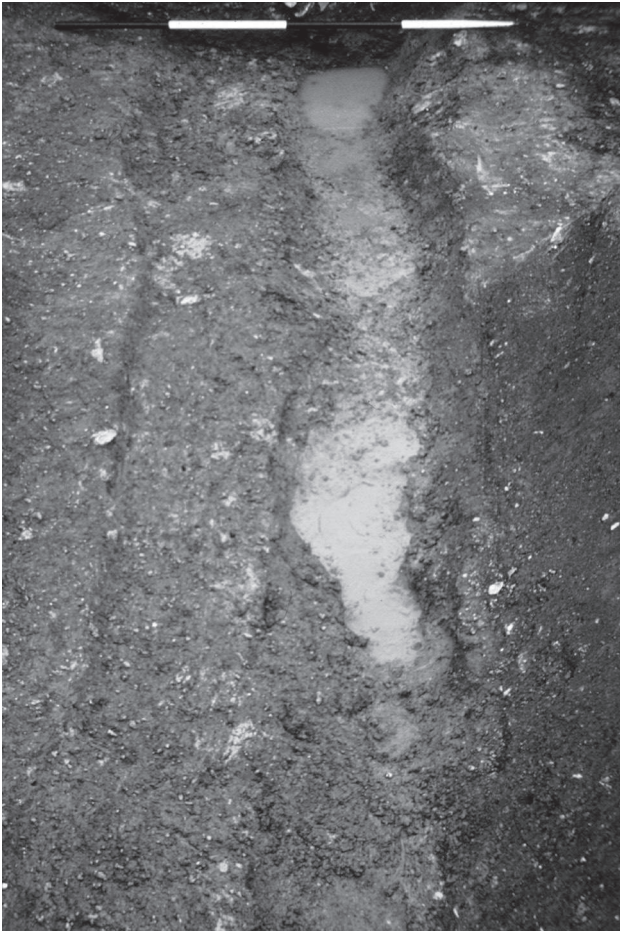
Fig. 2.40. Gully cgr78: LUB 13. Looking south.

Further east, at right-angles to the line of the feature, and cutting dumps cgr70 (LUB 12) was another linear feature cgr78 running north–south. It was at least 5.75m long, 2.2m wide at the top, 0.23m deep and had gently sloping sides (Fig. 2.40). Its fill contained much building debris, largely stone and mortar, with some tile and stone roofing slates. It appears to have been recut cgr79; this new feature was at least 8m long, 2.35m wide and 0.43m deep; its fill contained much mortar but less stone than cgr78, together with painted plaster (approximately 9.8kg), tile and stone tesserae.

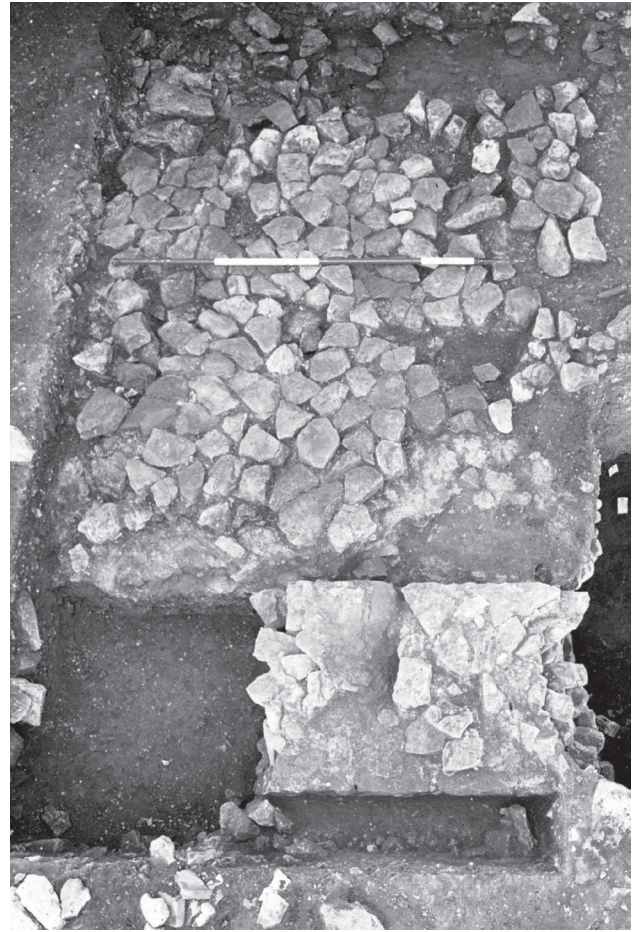
Fig. 2.41. Late Roman surface cgr55 in Structure R3A.2: LUB 14. Looking north.

In room 3A, surface cgr50 (LUB 9) was sealed by building material and other debris cgr53 (0.2m thick, with its top at 17.82m OD). This debris contained animal bone consistent with the interpretation of the deposit as the dumping of products of ‘boning out’ carcasses into an accumulation of demolition debris (O’Connor 1989). It was sealed by a roughly cobbled surface of stones (2.8m by 3m) set in a gravelly mortar, and bedded on a thin layer of clay cgr55 (Fig. 2.41).

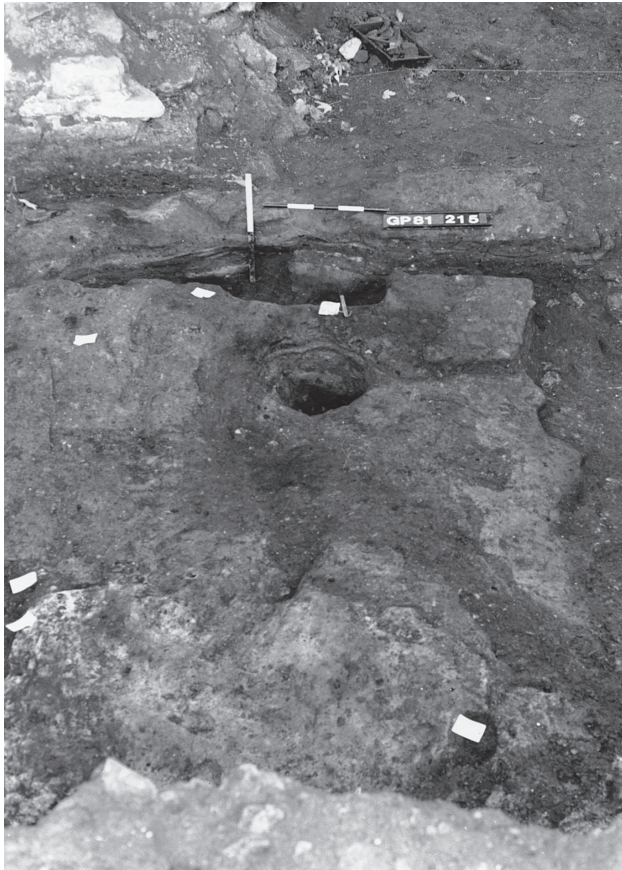
Fig. 3.23. Looking north at beam-slot cg30 of Structure 11 (LUB 16), cutting hearth cg23 and ashy layer cg27 of Structure 3 (LUB 13).

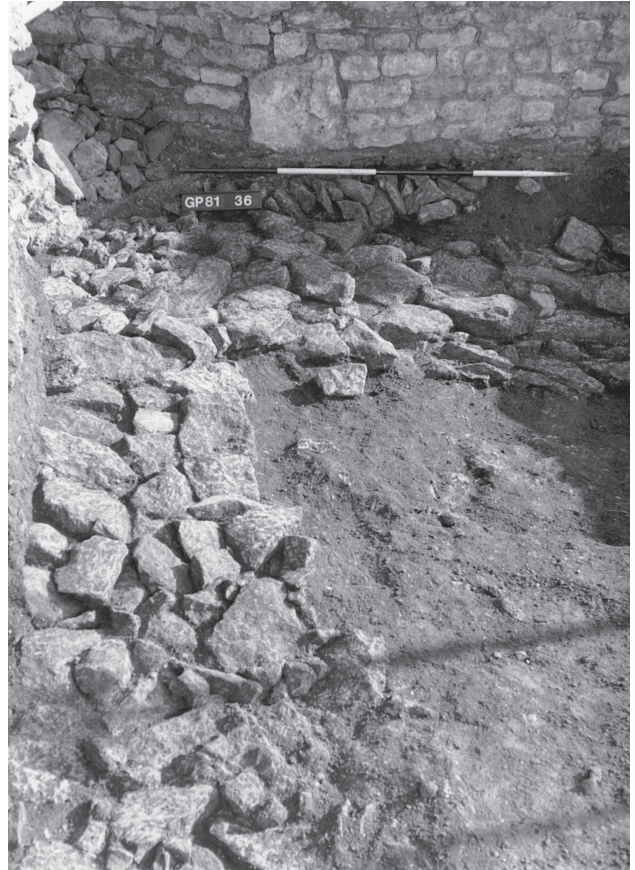
Fig. 3.24. Corner of wall cg55 of Structure 8: LUB 24. Looking east.

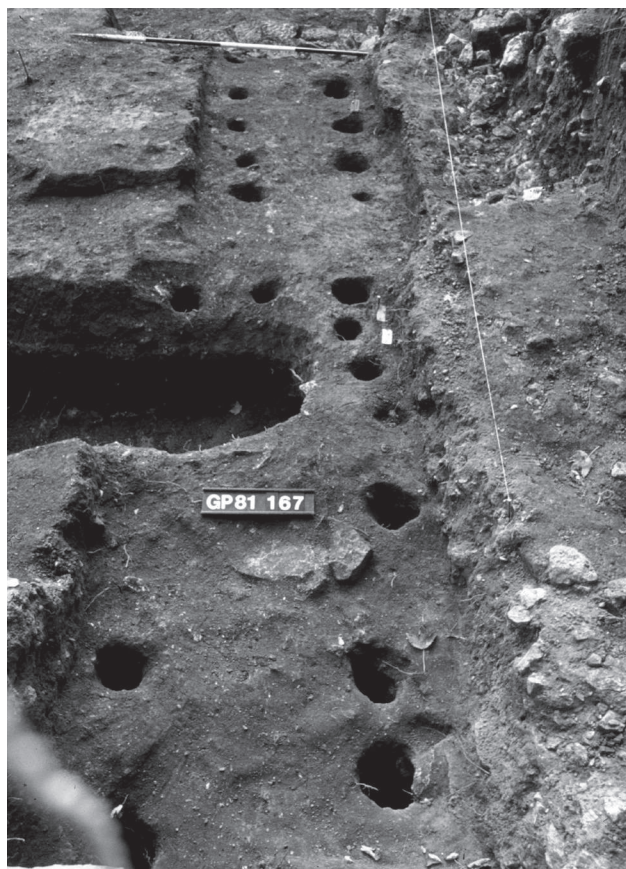
Fig. 3.25. Looking south along the construction trench of wall cg50 for Structure 9, showing piles cg47 and possible garderobe drain cg113: LUB 26.

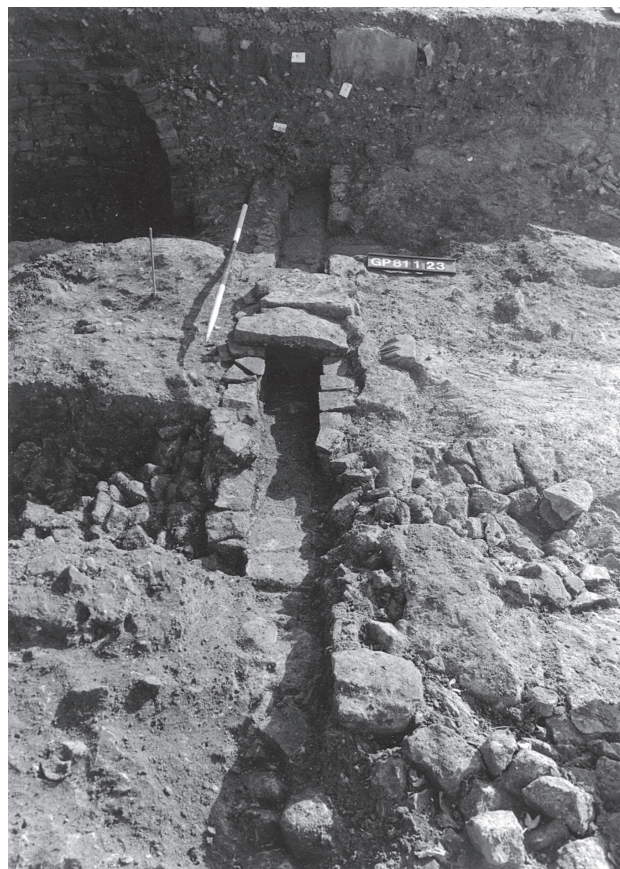
Fig. 3.26. Drain cg85: LUB 30. Looking west.

but running towards the southern end of wall cg50 of Structure 9 (Cope-Faulkner 2008). This could, however, represent a separate structure completely. After Structure 9 was demolished (LUB 29), tile-lined drains (LUB 30) were inserted to the rear of Structure 8 (Fig. 3.26).

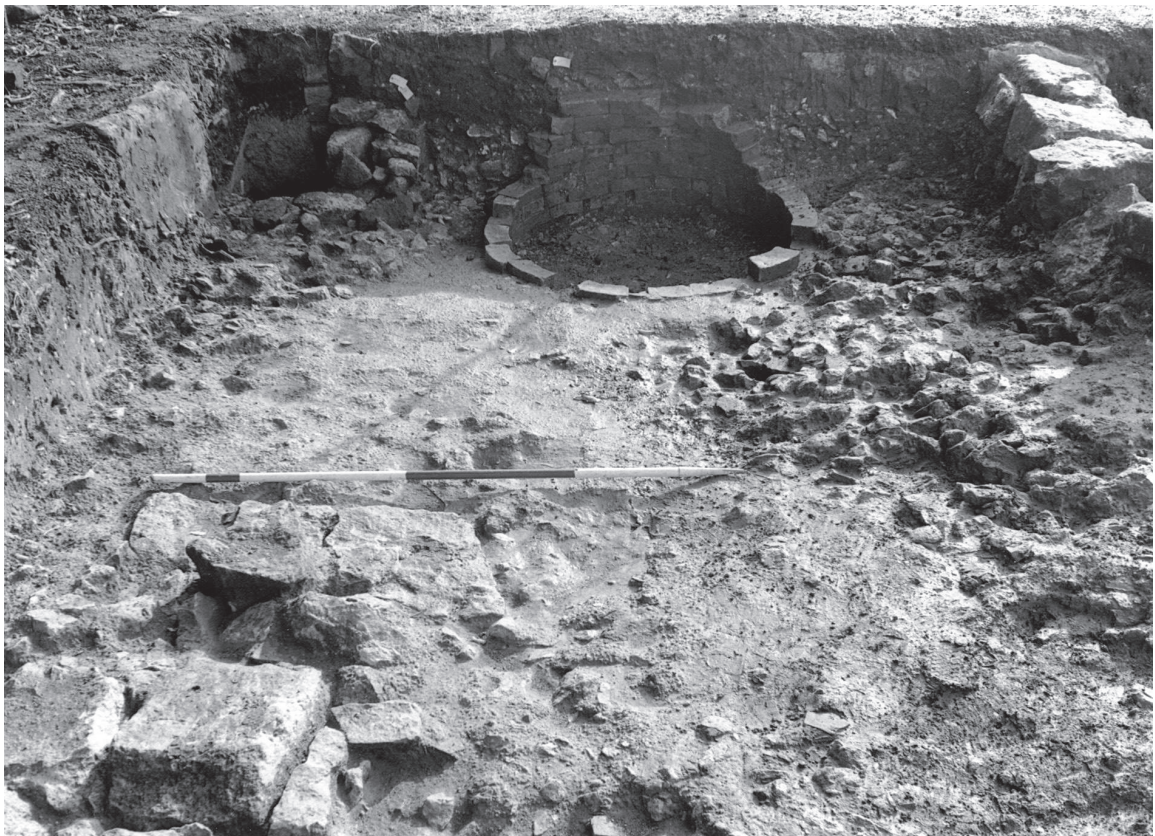
Fig. 3.28. Looking east at wall cg98 (right), brick-lined feature cg103 (left) and later soakaway cg101: LUBs 32, 33 and 34.

In the early to high medieval period a stone house, Structure 8 (LUB 24), was built along the Grantham Street frontage. A stone extension or separate building, Structure 9 (LUB 26), abutted it to the rear. Structure 9 was demolished (LUB 29) later in the medieval period and Structure 8 (LUB 31) some time later. The buildings were apparently still standing when John Speed visited the city in 1607 to prepare his map, but may have been demolished at the same time as those at the f72 site to the east, c 1700 (R H Jones 1980, 44–5). The next building to occupy the site, Structure 10 (LUB 32), was not built before the late 18th century, and had a stone-walled cellar (Fig. 3.27), buttressed on the south; this too fronted Grantham Street. It was almost certainly one of the row of three-storeyed terraced houses built here in the 1840s: they are visible on Padley's 1851 map (Mills and Wheeler (eds) 2004, 64), but not on the 1842 version. These were built in brick, but on stone foundations. Various features to the rear (Fig. 3.28) were probably associated with this structure.

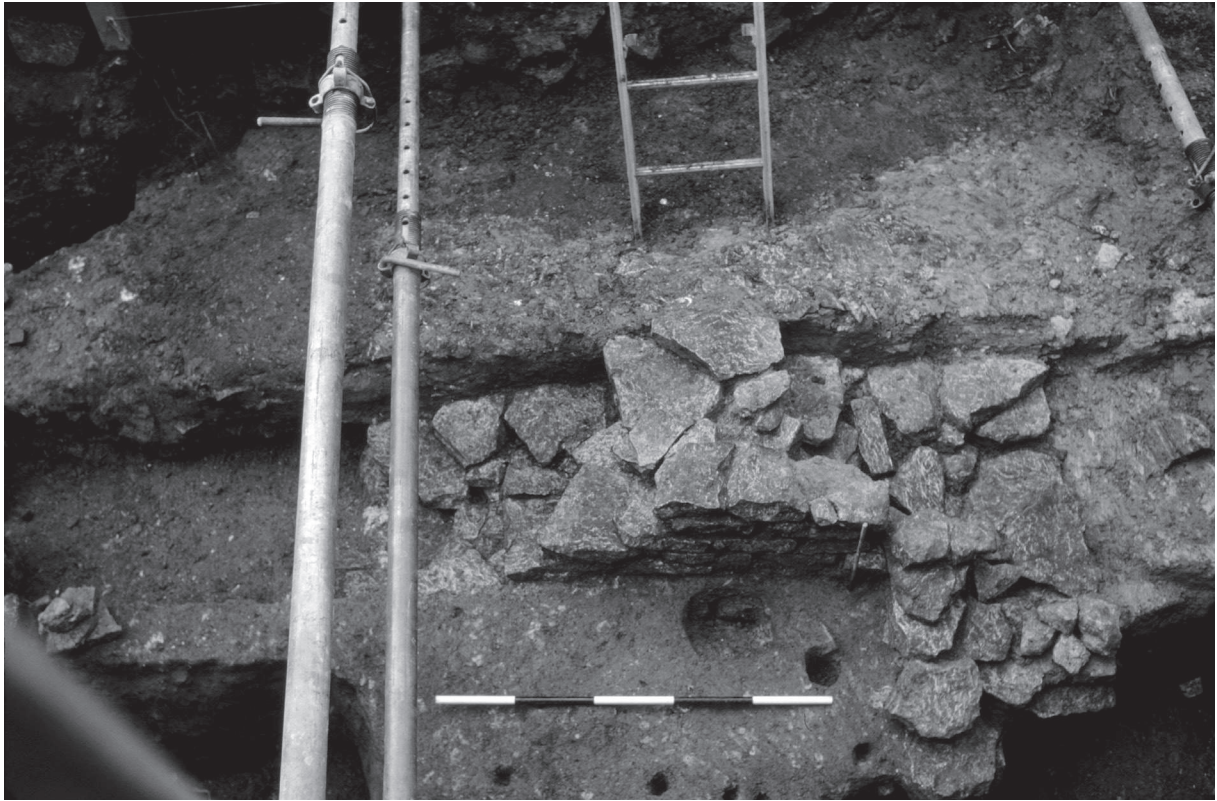
Fig. 4.21. Wall cg5 of Structure 1.1, and postholes cg15 of Structure 1.2: LUBs 6 and 7. Looking west.

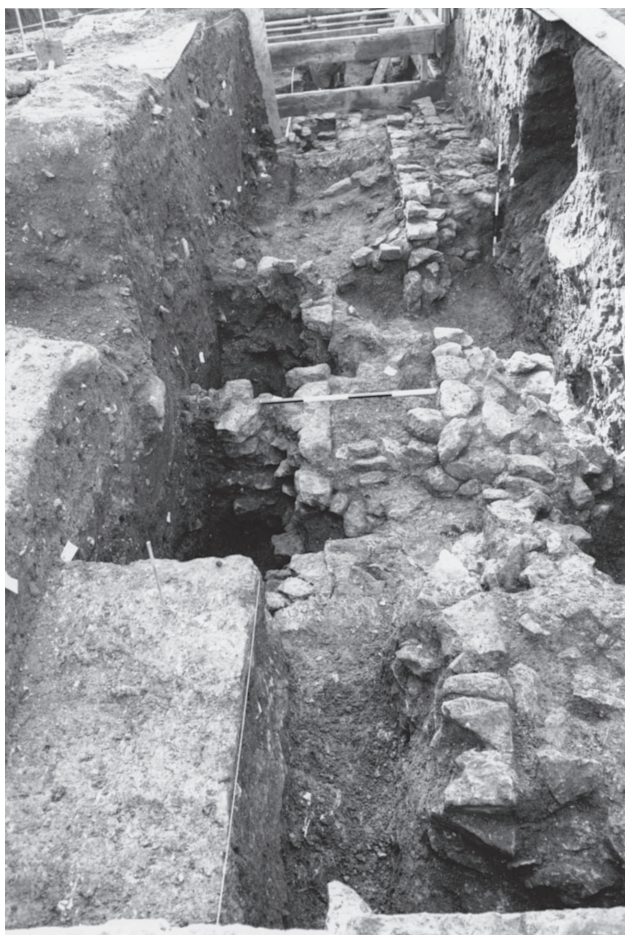
Fig. 4.22. Looking south at wall cg50 of Structure 1.6 on the left; wall cg53 of Structure 3 on the right; pits cg69 (left foreground) with cg72 beyond, and cg85 (right foreground) with cg63 behind: LUBs 17, 19, and 30.

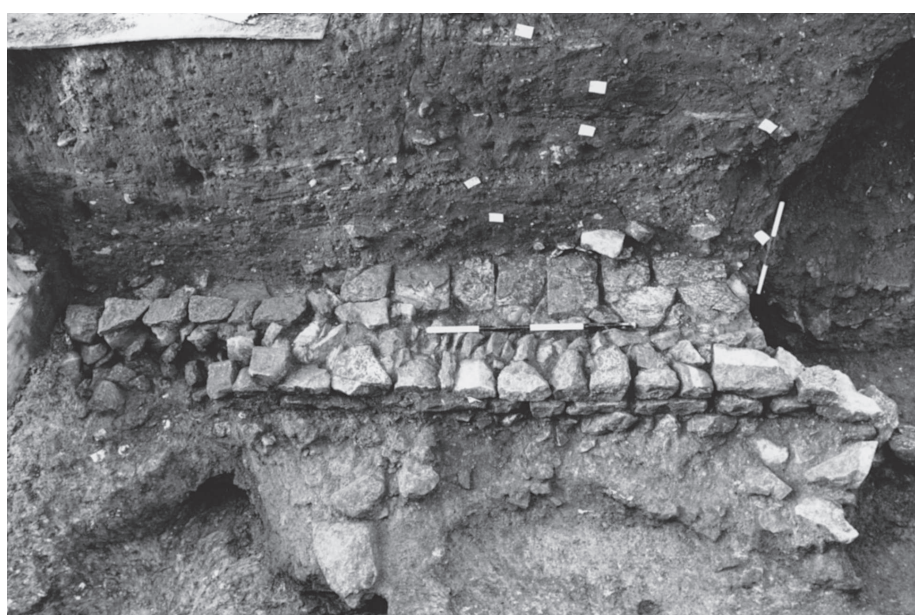
Fig. 4.23. Wall cg53 of Structure 3: LUB 19; looking west.

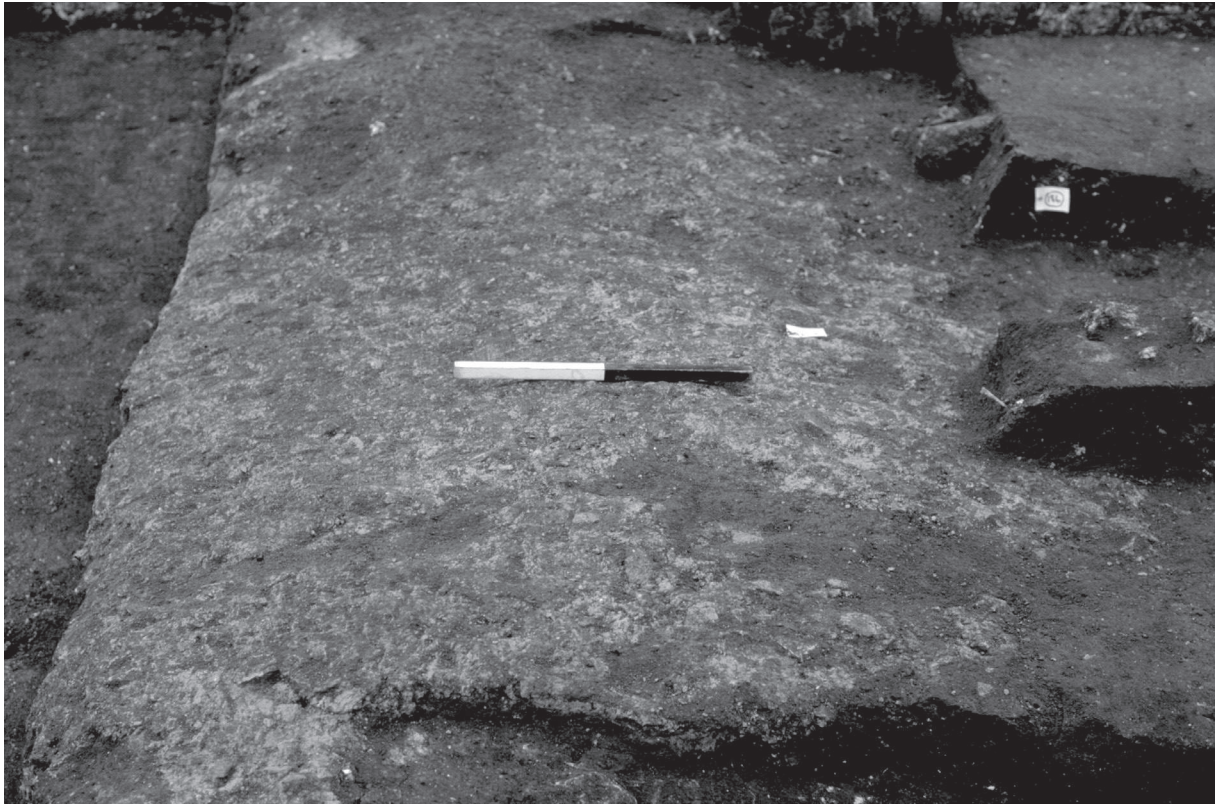
Fig. 4.24. Looking north at surface cg124 (LUB 25), cut away to the left by the deeper excavation in Area 2.

LUB 25 Surface (Fig. 4.24)

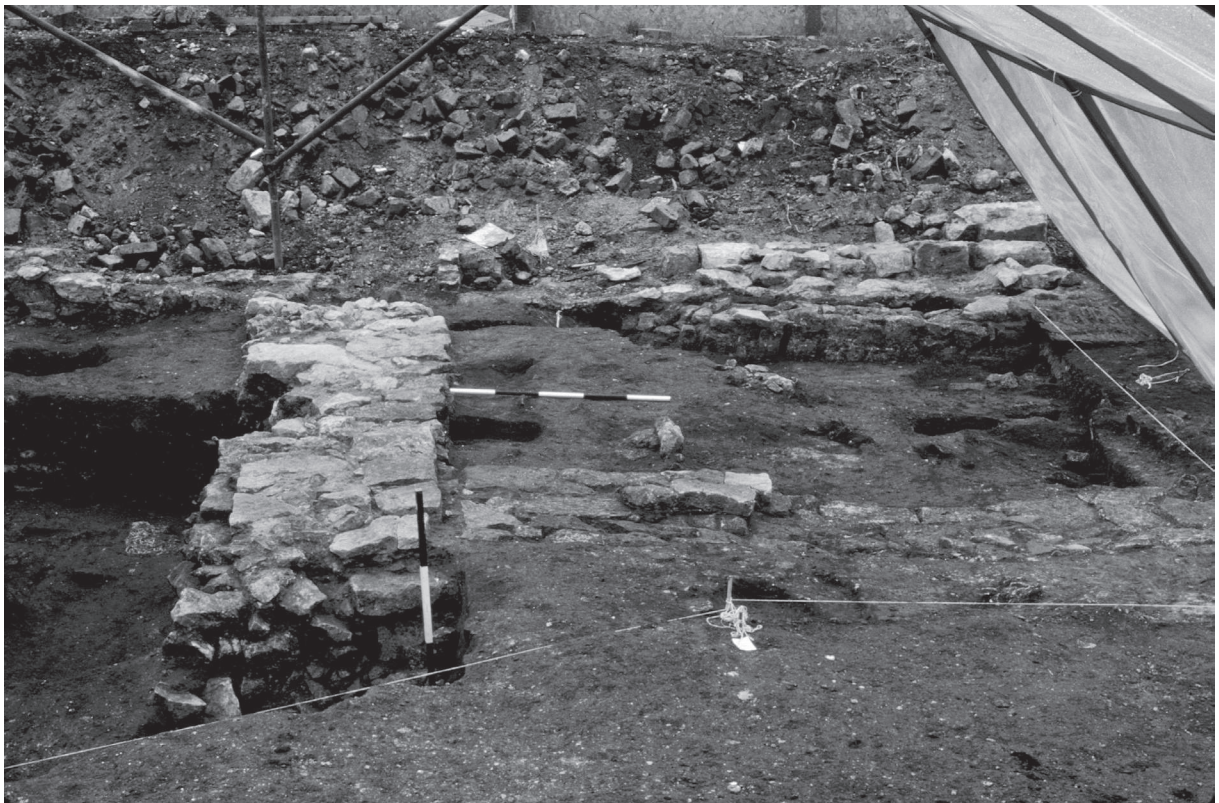
Fig. 4.25. Structure 12, looking north. Wall cg128 (left) with cross-wall cg140 of Structure 12.2 just visible on the surface in the foreground, and wall cg213 beyond: LUBs 41 and 47.

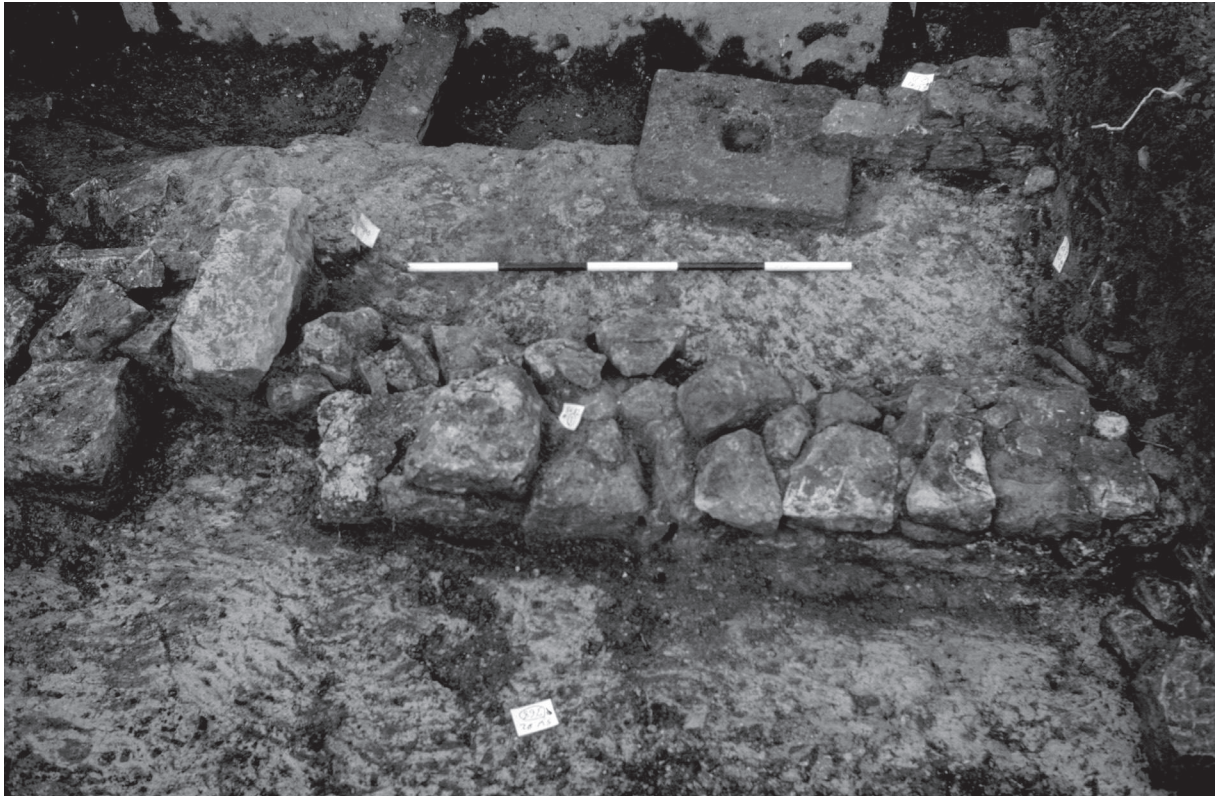
Fig. 4.26. Structure 13, looking north. East-west walls cg205 (left background) and cg167 (with possible pillar base, right background); clay floor cg168 of Structure 13.1 in the foreground, sealed by wall cg129 of Structure 13.2: LUBs 43, 44, and 48.

At the western end of the site, Structure 13 was delimited by stone walls cg171 (0.8m wide) to the west, and cg215 (1m wide), 4m to its east. Within the building there was a cross-wall cg167, 0.4m wide with a large square block, possibly a pillar base, at its west end (Fig. 4.26). The block (21) <811>, 0.5m square and 0.3m thick, with a depression 0.058m deep in its upper face, was reused here but probably had been intended originally to serve as a post-pad for a minor upright within a timber building (Stocker 1984a). A further section of wall cg205, 0.48m wide and running at an oblique angle, may have represented a continuation of the cross-wall cg167. All of the pottery (32 post-Roman sherds) from cg171 and cg215 was of 10th- to 13th-century date, apart from one 15th- or 16th-century MP sherd and one 15th-century LLSW sherd.

LUB 44 Structure 13.1: use (Fig. 4.26)

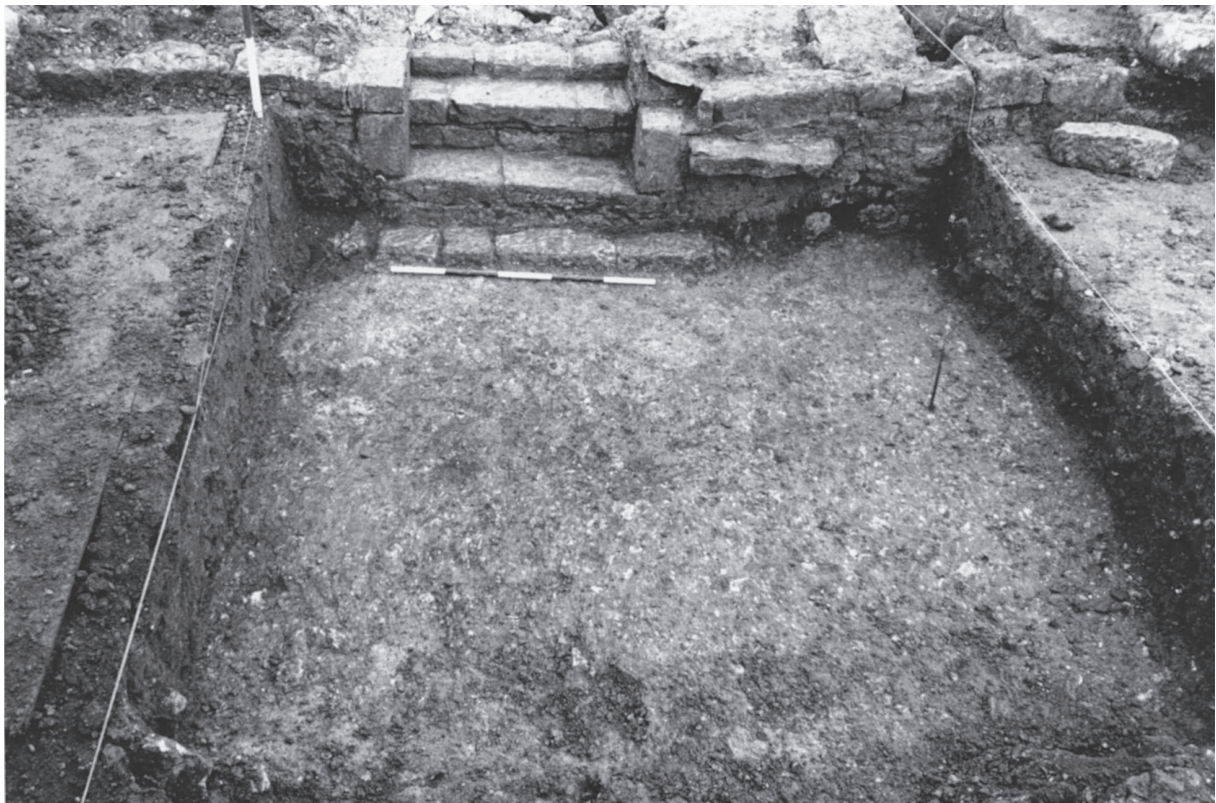
Fig. 4.27. Structure 14, looking north. Cellar floor cg103 and north wall cg102 with steps: LUB 51.

LUB 52 Structure 14: use (Fig. 4.27)

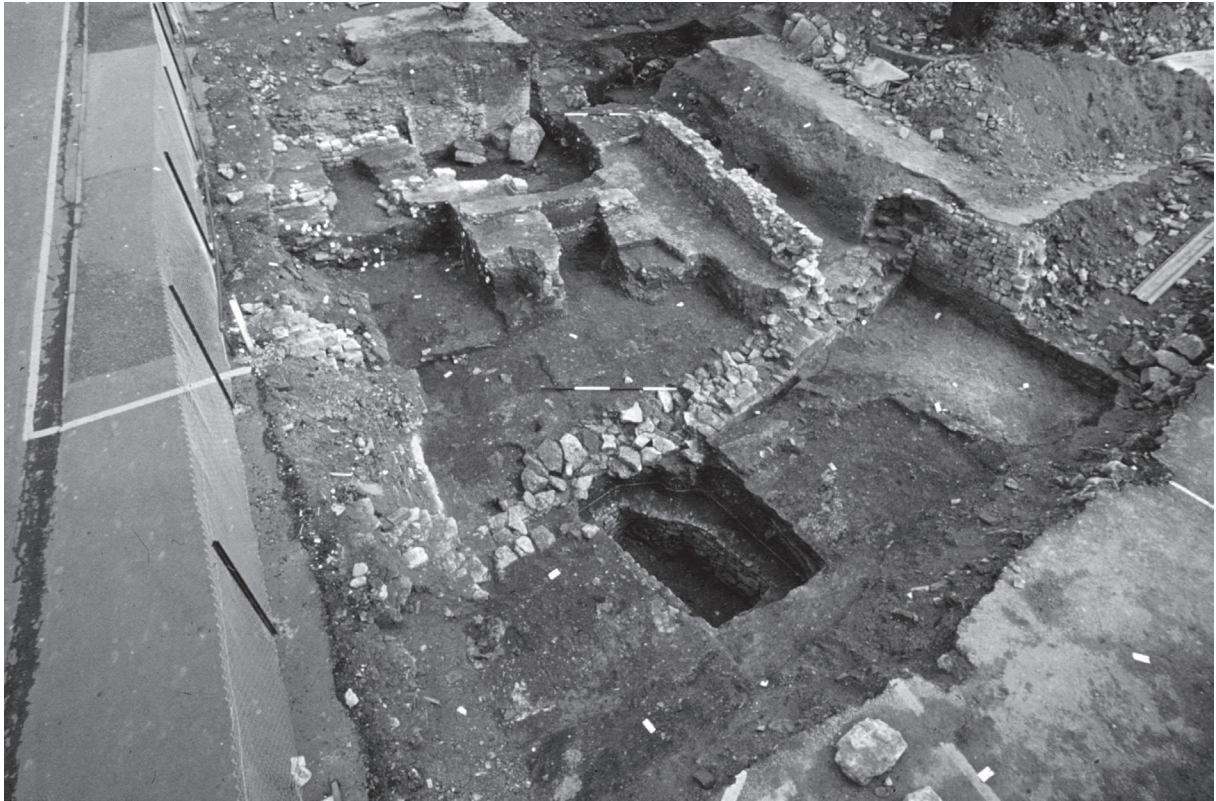
Fig. 5.26. Looking north-east at stone-lined garderobe cg106 of Structure 4 in foreground, with the foundations for wall cg129 to right and Roman wall cg110 visible as foundation towards far right: Trench I, LUBs 1, 21 and 30.

Trench IA. Structure 4 (LUB 12), constructed towards the southern limit of Trench IA, had a north wall (partly reusing possible Roman wall cg110, LUB 1; Fig. 5.26) that acted as a terrace. This wall continued in use into the modern period as the south wall of Structure 24 (LUB 41). Structure 8 (LUB 55) continued in use in Trench II, while Structures 9 and 10 (LUBs 53 and 54) were built to its west. Structure 9 was terraced into the hillside. Structure 10 was replaced by Structure 14 (LUB 58; Fig. 5.33), also terraced. Structure 33 (LUB 57) stood in the south-eastern corner of Trench II, to the south of Structure 8.2 (LUB 55; Fig. 5.32).

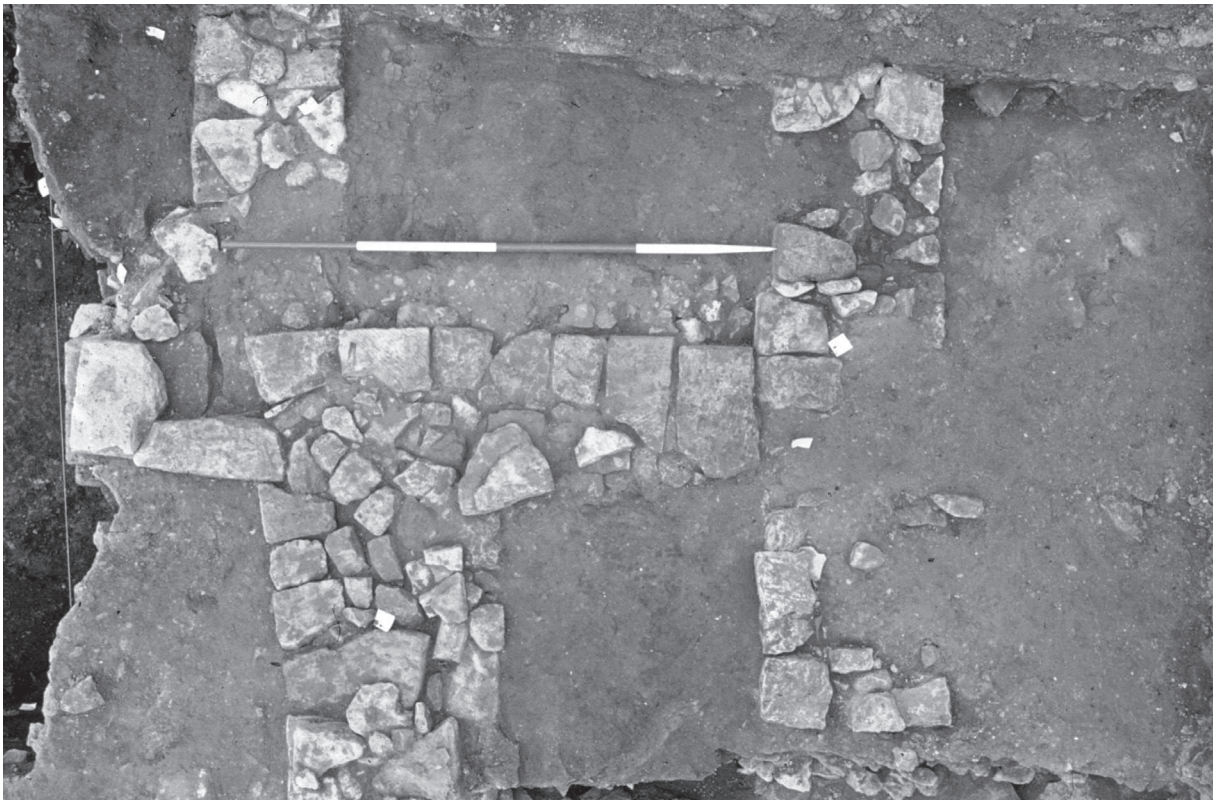
Fig. 5.28. The foundations for east–west walls cg73 (top left) and cg75 of Structure 15 (right); the foundations for walls cg152 of Structure 24 abut cg75 and run over cg73: Trench I, LUBs 16 and 41.

In the late medieval period, Structure 15 (LUB 16; Fig. 5.28) was built in the central two plots of The Strait properties; it had a yard with drains to the rear (LUB 17; Fig. 5.29). This building probably

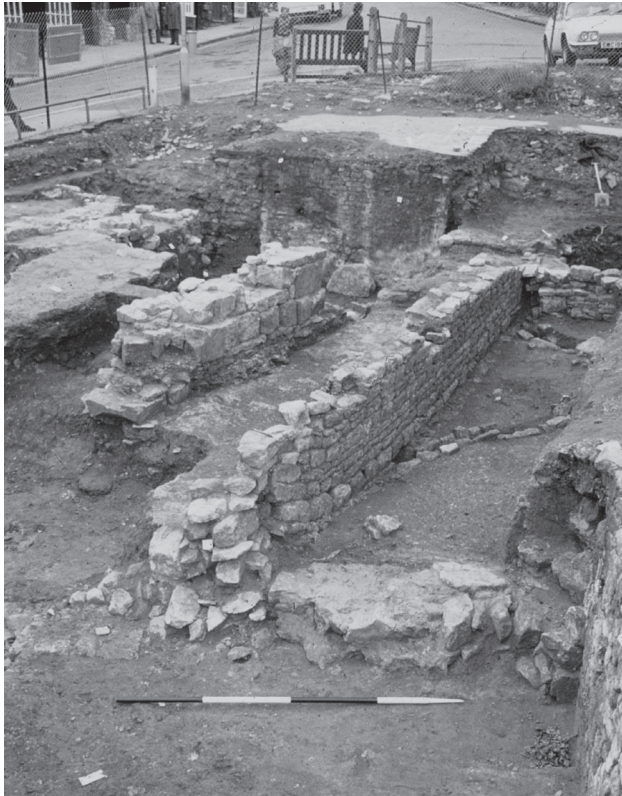
Fig. 5.29. Looking north-west at north-south walls cg129; drains cg123 and cg126 to the right, and later walls cg134 (behind, to right) and cg154 (behind, to left): Trench I, LUBs 17, 21, 23, and 41.

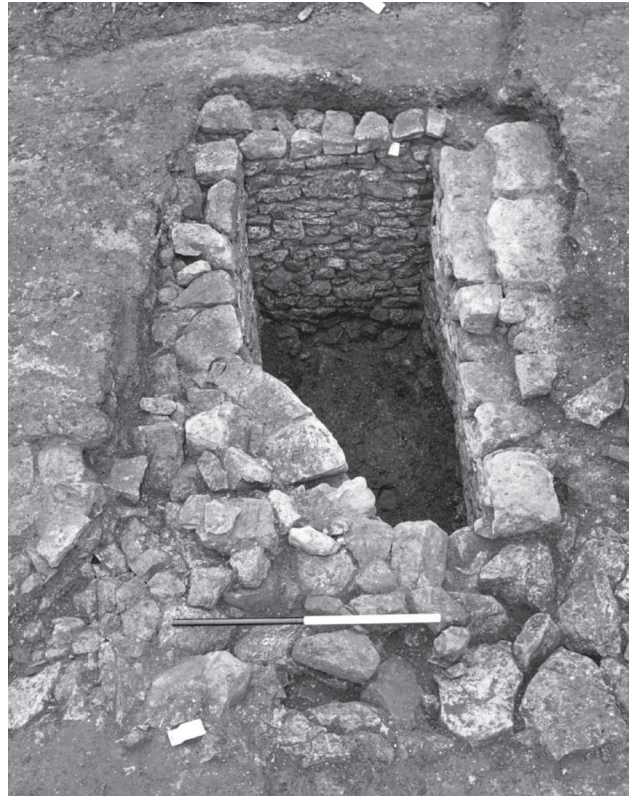
Fig. 5.30. Wall cg109 and garderobe cg106, Structure 4: Trench I, LUB 30. Looking south.

A stone-lined garderobe cg106 was built against its north wall cg117 (LUB 12). The garderobe was sub-rectangular in plan, narrowing at the point where it met wall cg117. Its construction involved the removal at this point of some of the south face of wall cg117. The void was then covered by wall cg109 to bridge over the junction with cg117 (Figs 5.26 and 5.30). Architectural fragments reused in the garderobe lining cg106 and superstructure cg109 included four pieces that almost certainly came from the same monolithic lintel (MY) <DT74 I St52–3>, (OE) <DT74 I St41–2>. It has a very shallow curvature, and can be reconstructed to form a flat arch-head as was commonly used on fireplaces in the late medieval and post-medieval periods (Stocker 1984a), implying that the garderobe was a late addition to Structure 4. Only five residual sherds were recovered from the lowest garderobe fill cg107, which was of loose material with traces of mortar, clay and wood.

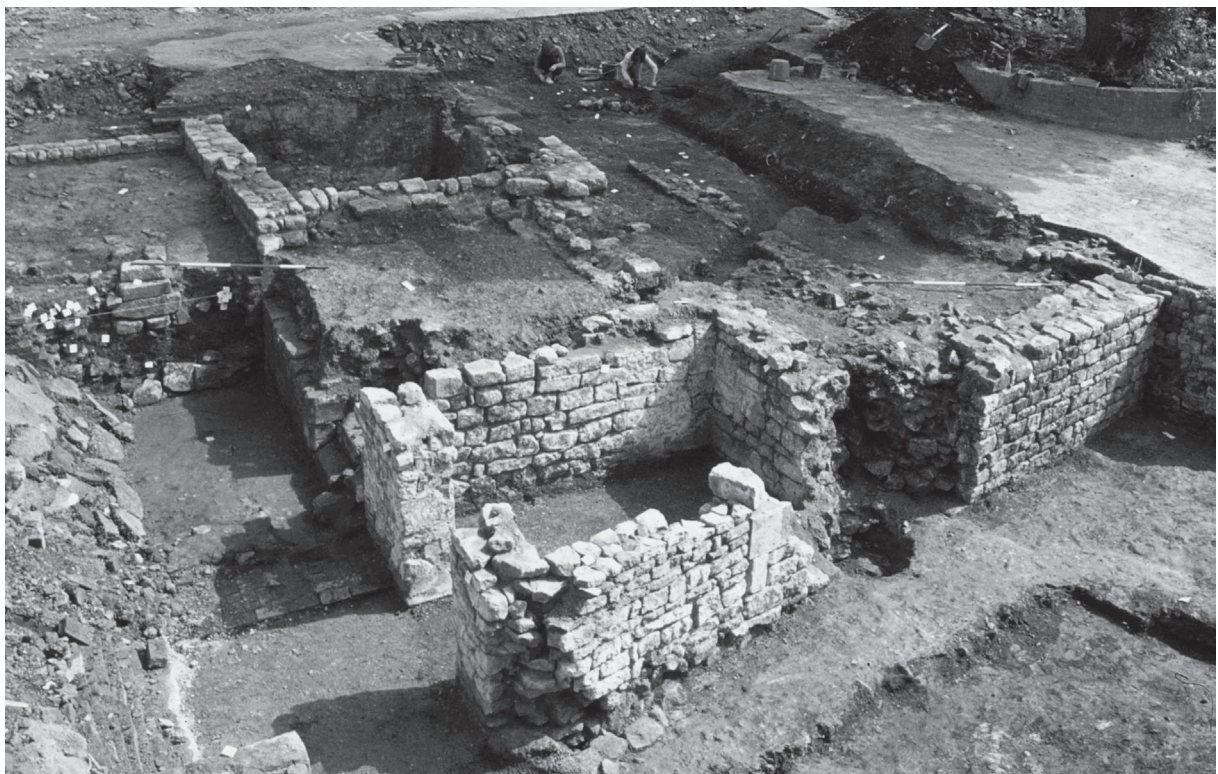
Fig. 5.31. Looking north-east at cellars, Structures 29 (top) and 30: Trench I, LUBs 46 and 47.

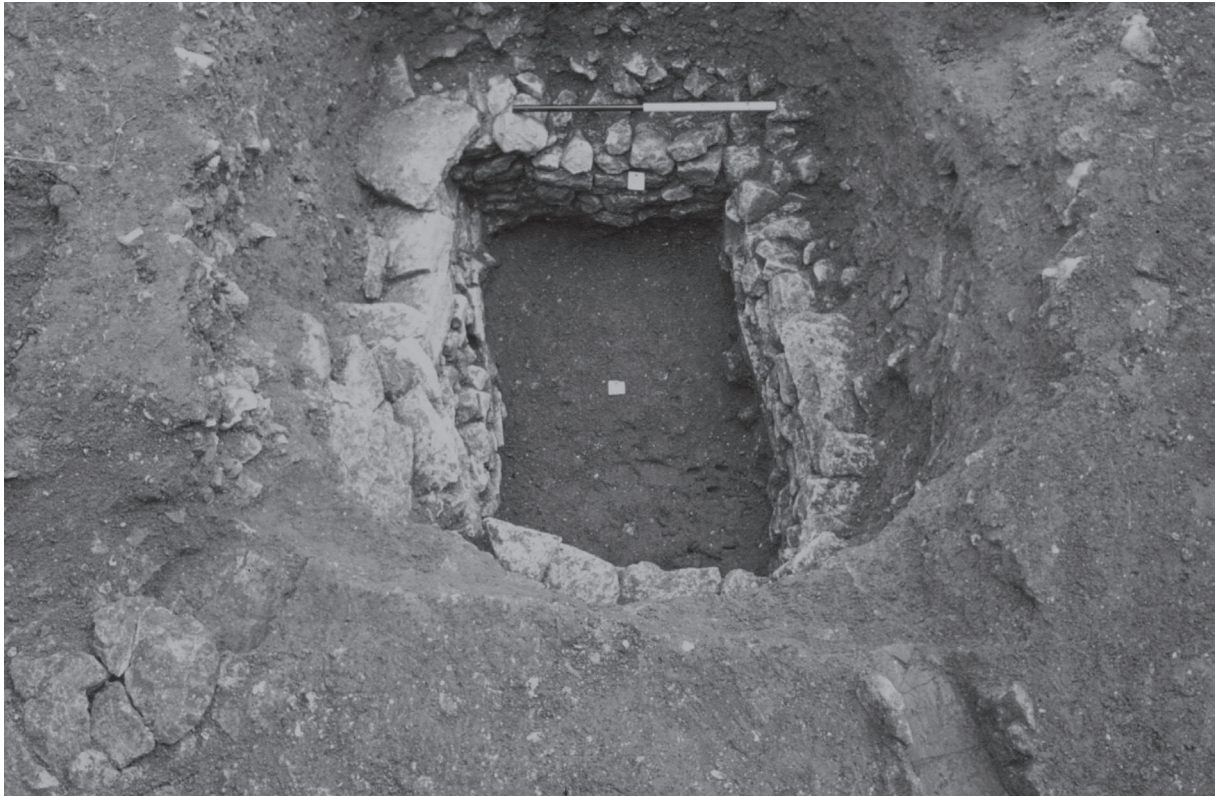
Fig. 5.34. Looking east at stone-lined cess pit with drainage channels cg284: Trench II, LUB 67.

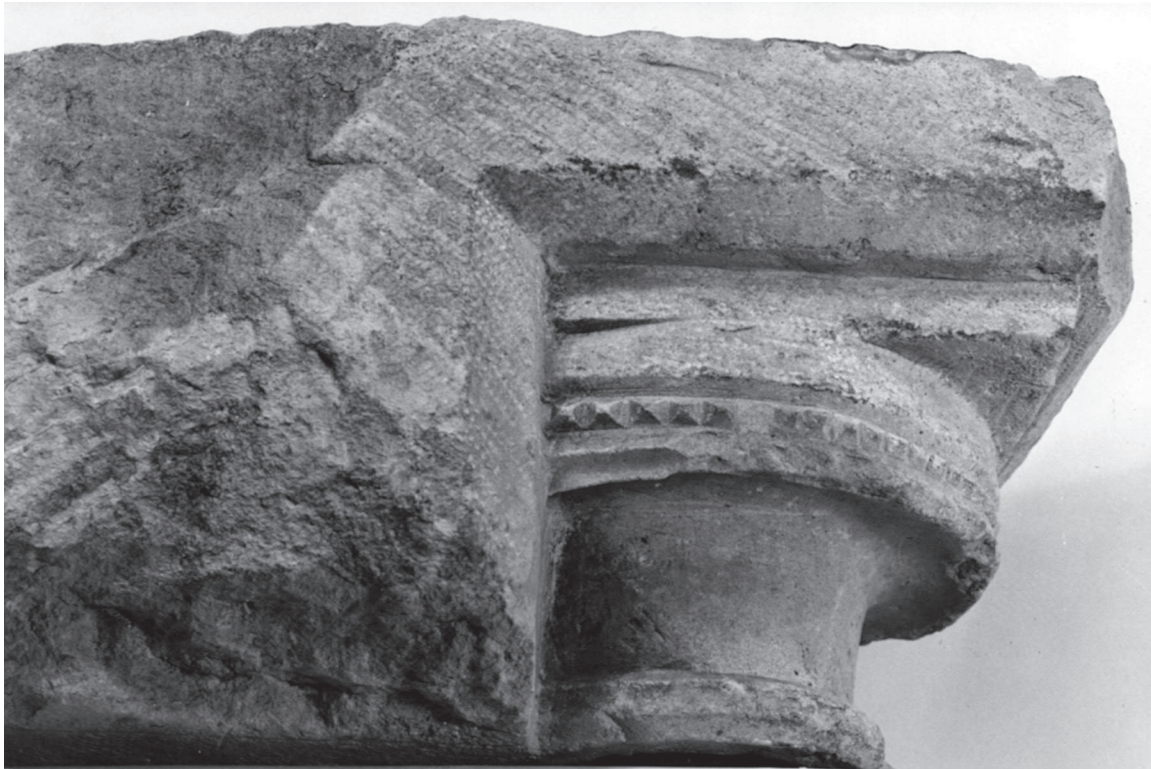
Fig. 5.37. Moulded Norman capital from blind arcading, possibly derived from Structure 12 but reused in Structure 24.

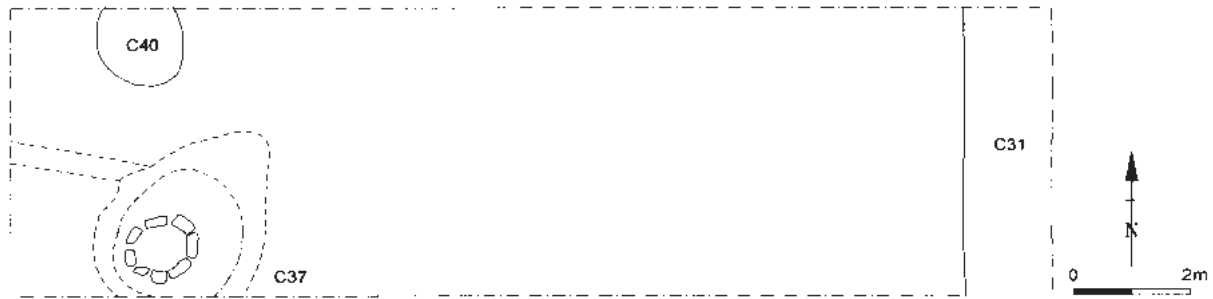
Fig. 6.40. Trench C; city wall cgC31, well/cess pit cgC37 and pit cgC40: LUBs 69, 75 and 77.

LUB 75 Well or cess pit (Figs 6.40 and 6.50)

LUB 77 Pits (Figs 6.40 and 6.49)

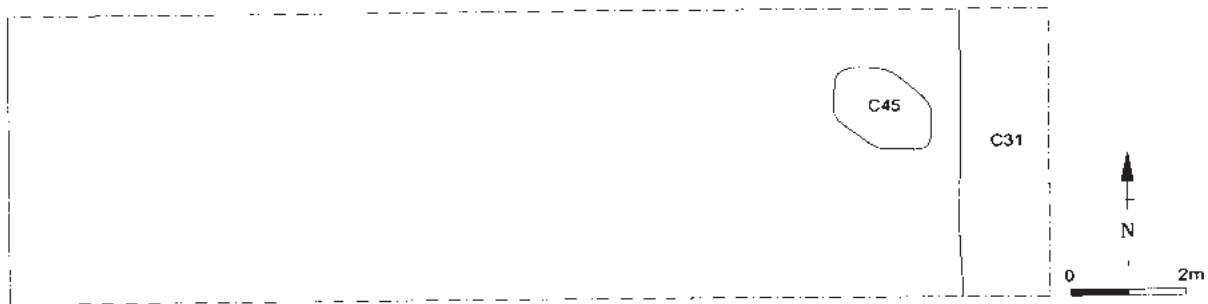
Fig. 6.41. Trench C; city wall cgC31 and pit cgC45: LUBs 69 and 78.
